Historic Structure Report

**SAINT JOSEPH HALL
(THE POLISH CLUB)
HISTORIC STRUCTURE REPORT**

**Salem Maritime National Historic Site
Salem, Massachusetts**

Building Conservation Branch, Northeast Cultural Resources Center
Northeast Region, National Park Service
U.S. Department of the Interior
Lowell, Massachusetts

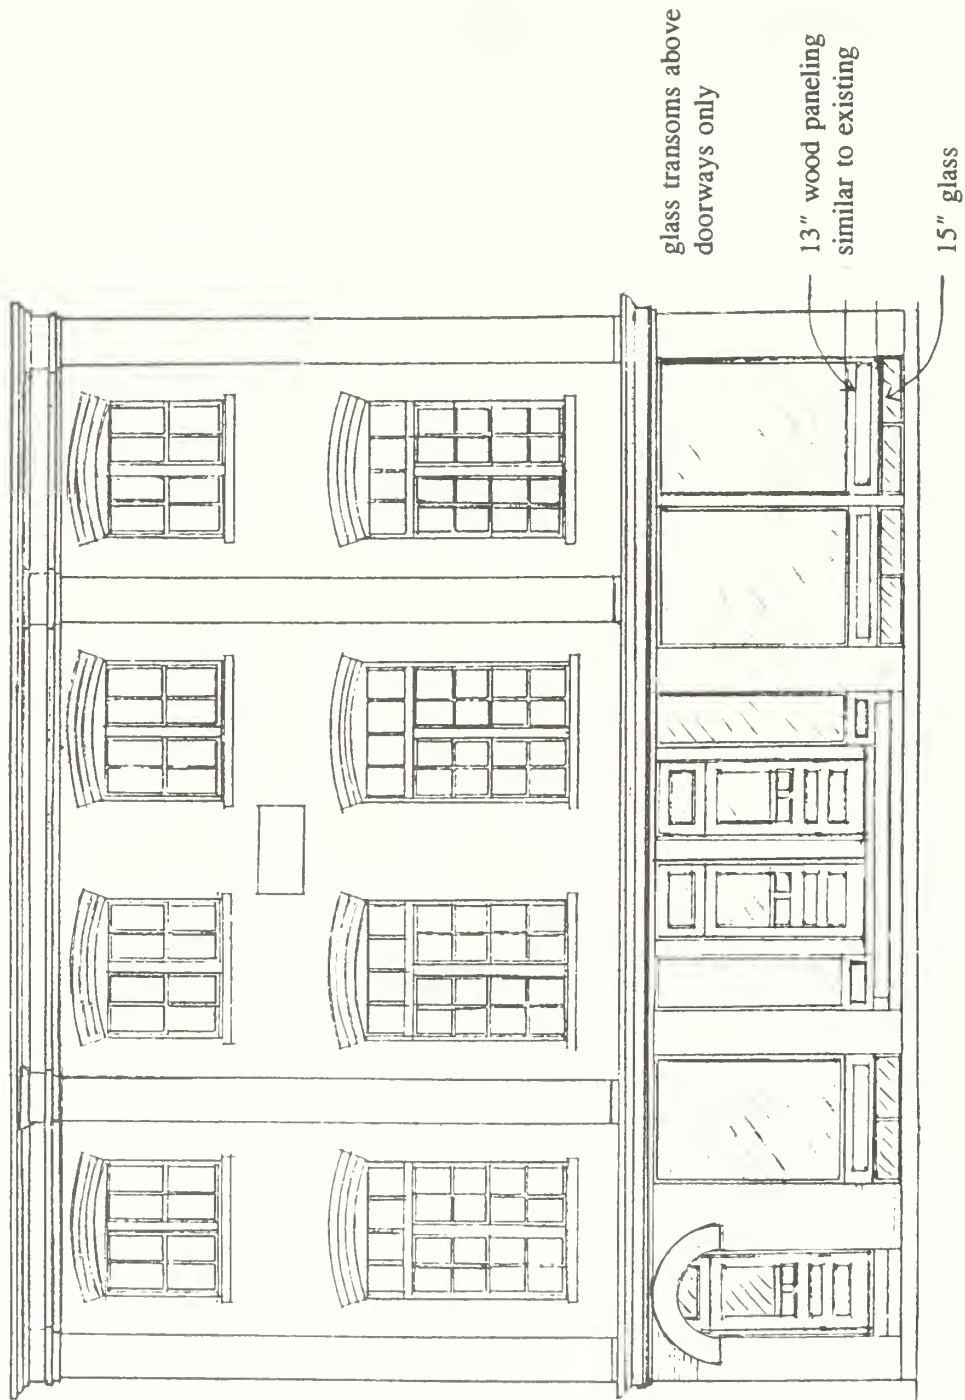
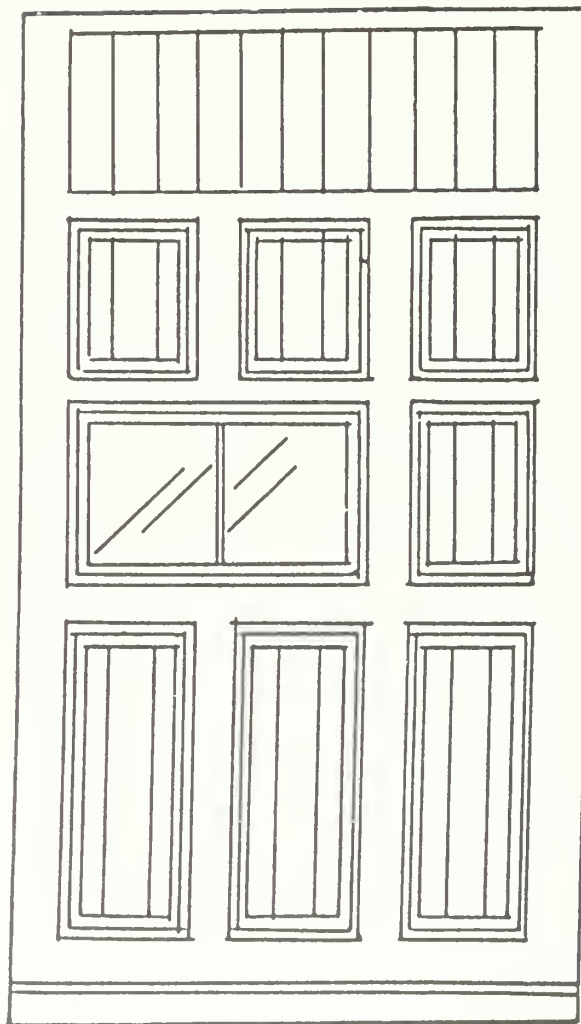
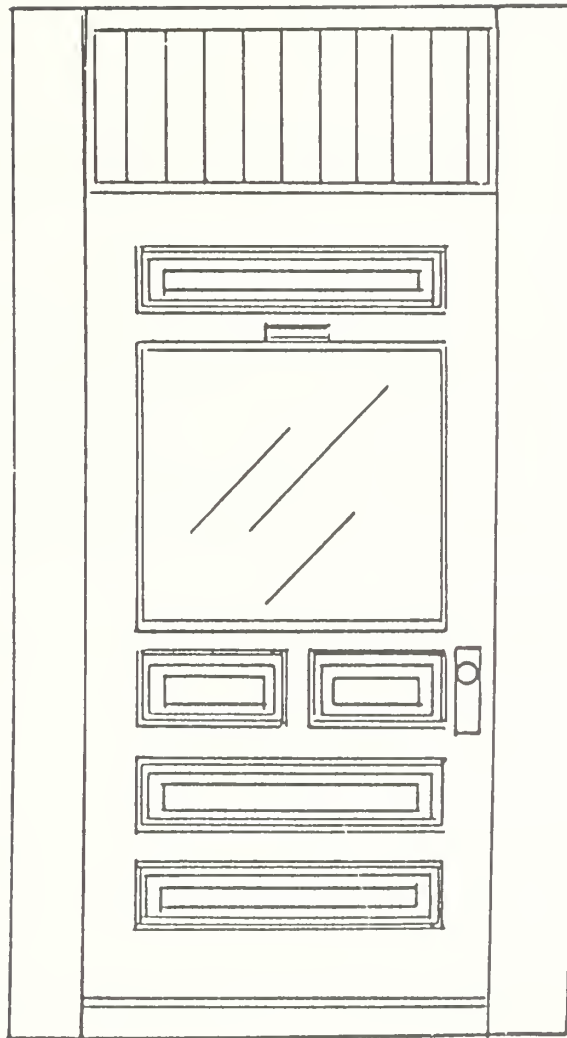
Figure 8. Polish Club building: conjectural appearance of south elevation, 1909.

The architect of the present Polish Club is not known. No original plans or drawings for its construction have been found. Based on all of the evidence collected for this report, it is thought that the south (facade) elevation originally appeared as shown in figure 8.

It is recommended to restore the storefront if there is good reason to do so, i.e., for interpretation. Figures 8, 19, and 20 illustrate the historic appearance of the south elevation.

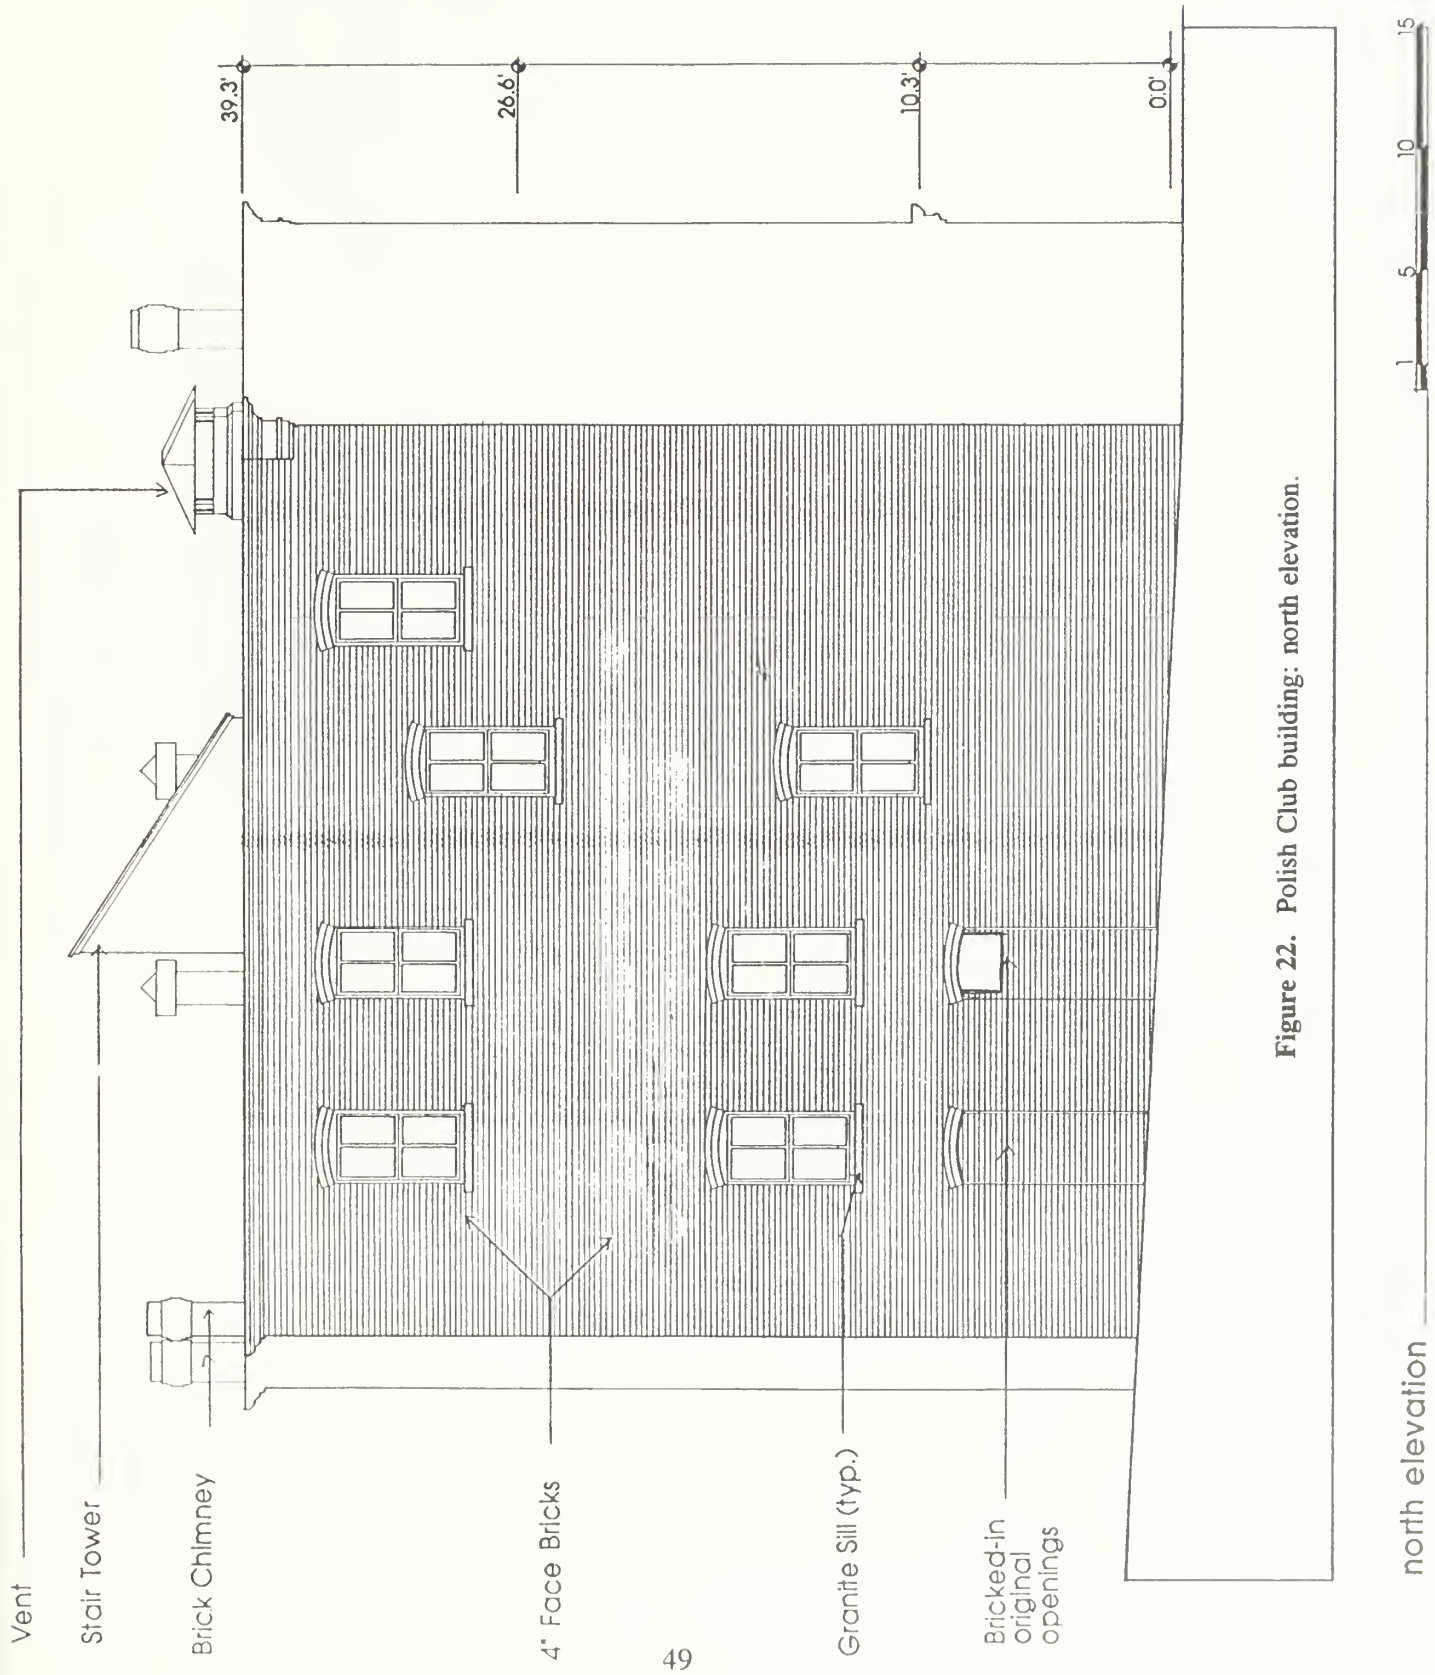
Figure 22. Polish Club building: north elevation.

The north elevation (fig. 22) has no cornice and no doorways. The two first-story windows were bricked up in the 1960s, the north one receiving a vent at the top.
